# Source Control Evaluation Addendum Operable Unit 2 Swan Island Upland Facility Portland, Oregon

Prepared for: Port of Portland

December 27, 2011 1115-05

Michael J. Pickering, R.G. Associate Hydrogeologist, Ash Creek Associates

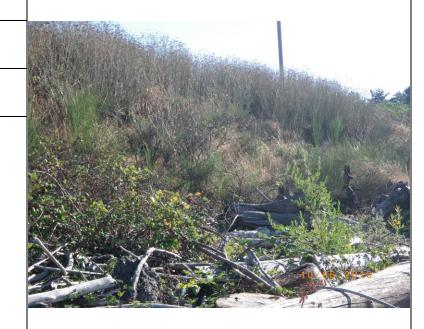
Photo No: 2

Typical grass/shrub vegetation on riverbank above OLHW.

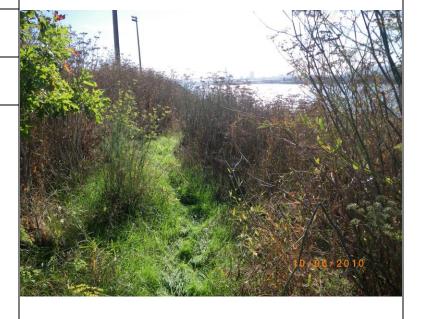
Photo No: 3

Typical grass/shrub vegetation on riverbank above OLHW.

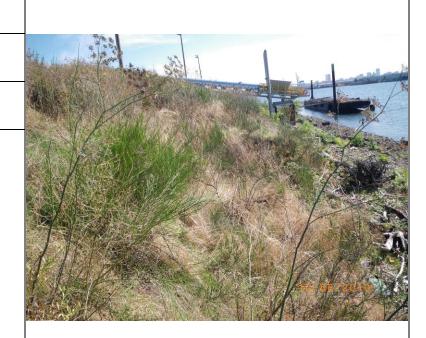
Photo No: 4

Typical grass/shrub vegetation on riverbank above OLHW.

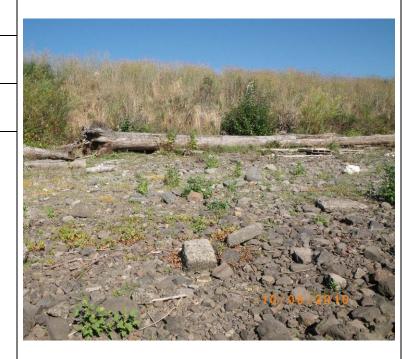
Photo No: 6

Example of sandy beach occasionally observed below OLHW.

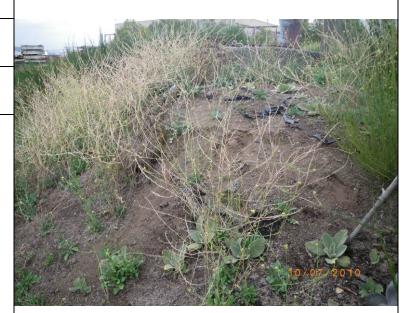
Photo No: 8

Feature B – Bare ground approximately 1 foot in diameter.

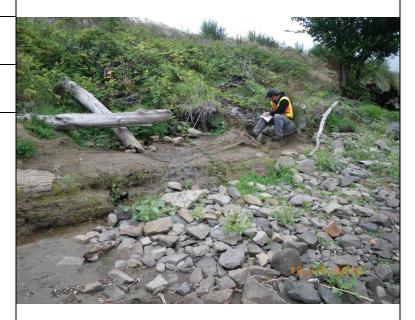
Photo No: 11

surface water in Photograph 11). The soil in the exposed surface differs from that observed

elsewhere on the bank and in upland borings. Instead of primarily sand that is observed elsewhere, the soil at this location consists of clayey silt exhibiting some cohesiveness.

Northwest end of Feature D – Bare ground below Outfall WR-399 with dimensions of approximately 3 feet by 80 feet.

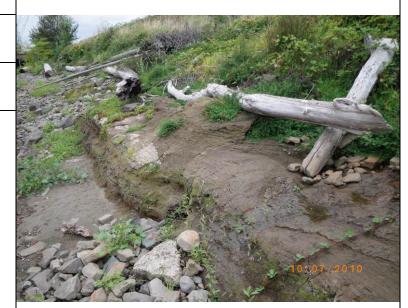
Photo No: 12

Sandy beach below Feature D.

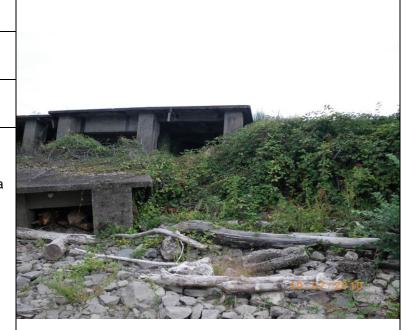
Photo No: 16

Northwest end of Feature G – War-era substation A platform.

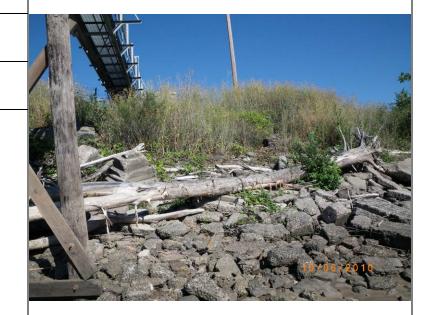
Photo No: 18

The erosion scarps are linear features running parallel to the riverbank. They are located at or above the transition from rip rap to vegetated riverbank. The total length of the scarps is 830 feet (or 30 percent of the total bank length). Of that total, approximately 300 feet of the scarps encroach below the OLHW (toe elevations ranging from 15.0 to 16.6 feet NGVD). As discussed in Sections 3.4 and 3.5, overland flow and river action are not likely causes of the observed erosion. Instead, the observed characteristics of the erosion are consistent with erosion resulting from wave action (caused primarily by boat wakes). The majority of the riverbank is covered with rip rap or dense vegetation and has no evidence of erosion, demonstrating that rip rap and vegetation are effective. It is likely that the erosion scarps originated in areas with a poor transition from rip rap to dense vegetation. For example, if the top elevation of the rip rap is below the OLHW in a particular location, upland vegetation at that transition may struggle to sustain dense growth from year to year. If, during a down year for vegetation, the river level is sustained at a level just above the rip rap, boat-wake action could initiate erosion that leads to a small vertical scarp. As long as the water level is above or below the location of the erosion scarp, no substantive erosion would occur. Whenever the water level is at the level of the scarp, however, the bank would be subject to additional erosion. Observations of the riverbank support this model. For example, at multiple locations, the vegetation has become well-established below the location of the erosion scarp (see Photographs 43 and 44). This indicates that at least one to two growing seasons passed without substantial erosion of the scarp.

cover is sufficient to withstand erosion from wave action (this is supported by the bank survey described above). A portion of the riverbank, however, has a visible erosion scarp near and above the OLHW. In the absence of maintenance of these features, when the river level is near the elevation of the erosion scarp, wave action is likely sufficient to cause erosion of the scarp face.

Feature I – Erosion scarp 35 feet long and up to 1.5 feet high.

Based on the presence of metals, PAHs, TBT, and PCBs above SLVs in riverbank soil, and the potential for erosion of the riverbank, a source control alternatives evaluation is recommended.

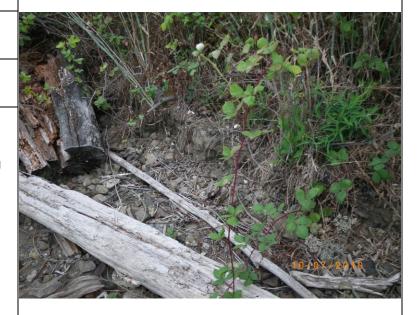
Photo No: 19

The location of the largest erosion scarp (J) is roughly centered on the aggregate barge conveyor serving the Cemex facility. The Cemex facility began operation in 2007. The most recent prior reconnaissance of the riverbank was conducted in October 2005 in association with the ecological risk assessment for OU2. The erosion scarp at feature J observed in 2010 was not observed at the time of the 2005 reconnaissance, suggesting that the bulk of the erosion associated with that feature occurred after 2005. This further suggests that much of the erosion may be associated with the movement of barges in and out of the mooring location.

Feature J – Erosion scarp 635 feet in length. Height is variable up to 6.6 feet. This photograph shows a minimal height scarp (hidden in vegetation).

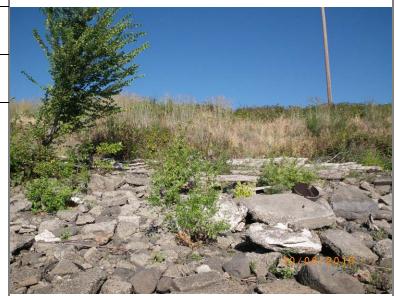
Photo No: 20

Feature J – Erosion scarp 635 feet in length. Height is variable up to 6.6 feet. This photograph shows a maximal scarp.

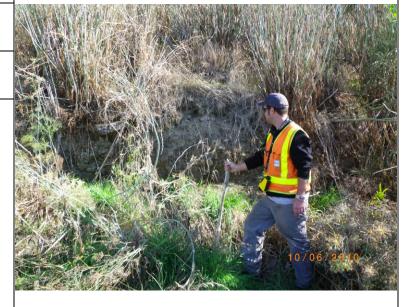
Photo No: 23

Erosion scarp 53 feet long and up to 2.7 feet high.

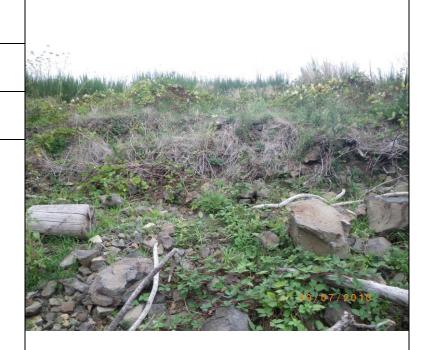
Photo No: 24

Feature N – Erosion scarp within depression in riverbank. Erosion scarp is 49 feet long and up to 2 feet high. Depression width is approximately 80 feet. Topography is hummocky and surface is densely vegetated.

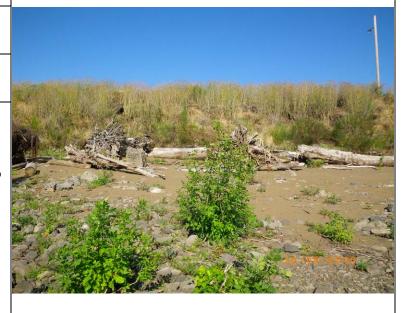
Photo No: 25

Feature O – Depression in riverbank. Width is approximately 50 feet. Topography is hummocky and surface is densely vegetated.

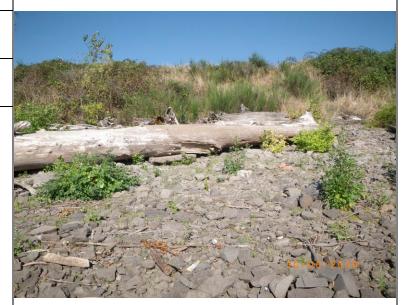
Photo No: 26

Feature P – Erosion scarp 2.1 feet long and up to 1.1 feet high.

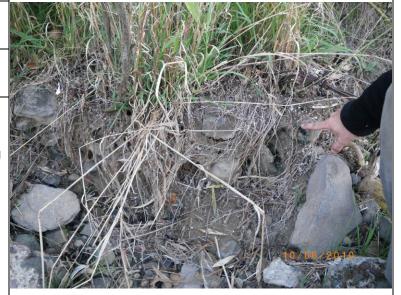
Feature Q – Outfall 163.
